Manhole Inspection Summary

Manhole # S41G__005MH

Insp Date: 11/3/08 2:40 PM

Location Address: **e. lombard st**

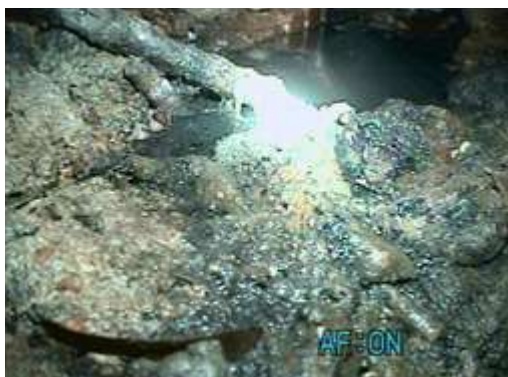
Defect 5

Condition: ☐ Sound ☐ Cracked ☐ Root Intrusion ☐ Deteriorated ☐ Leaks ☒ **Debris**

channel debris

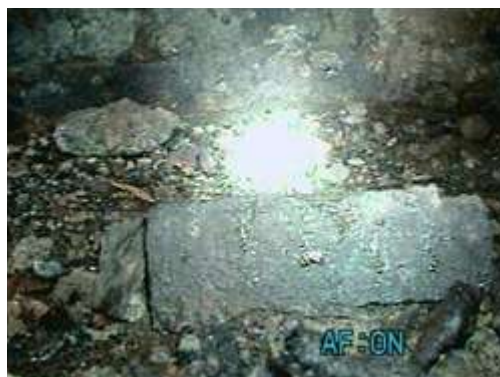
Defect 4

Condition: ☐ Sound ☐ Cracked ☐ Root Intrusion ☐ Deteriorated ☐ Leaks ☒ **Debris**

bench debris

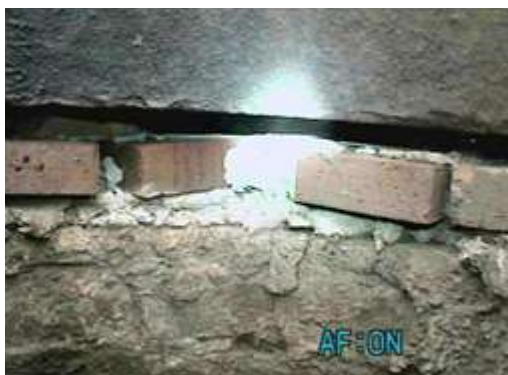
Defect 3

Condition: ☐ Sound ☒ **Cracked** ☐ Root Intrusion ☒ **Loose Brick** ☒ **Deteriorated**

cracked, loose bricks and deteriorating chimney/frame adj

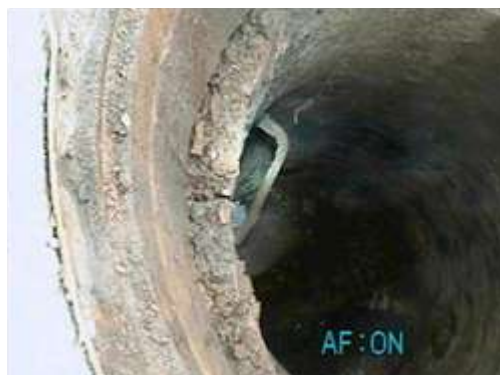
Defect 2

Frame Offset: **2** (in.) Condition: ☒ Sound ☐ Cracked ☐ Leaks

offset

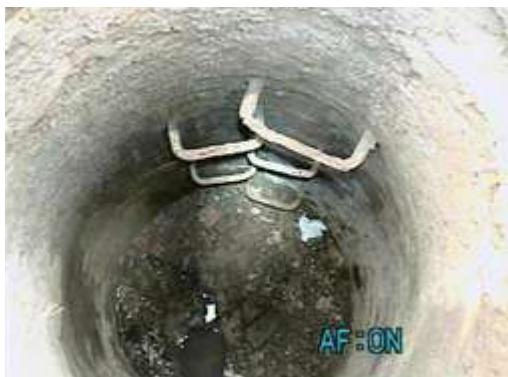
Defect 1

Infiltration: ☐ None ☒ **Joint** ☐ Cracks ☐ Mortar ☐ Roots ☐ Wall

Infiltration: ☐ None ☐ Joint ☐ Cracks ☐ Mortar ☐ Roots ☒ **Wall**

Steps Count: **5** Missing: **0** ☒ **Corroded**

corroded steps, signs of infiltration from chimney joint and barrel wall

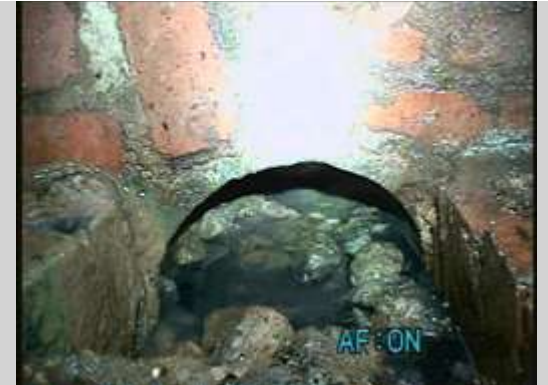
12 O'Clock Outflow

Deposits: ☐ None ☐ Mud ☐ Sludge ☒ Debris ☐ Grease

Silt Depth: 5 (in.) Deposits Extent: Medium

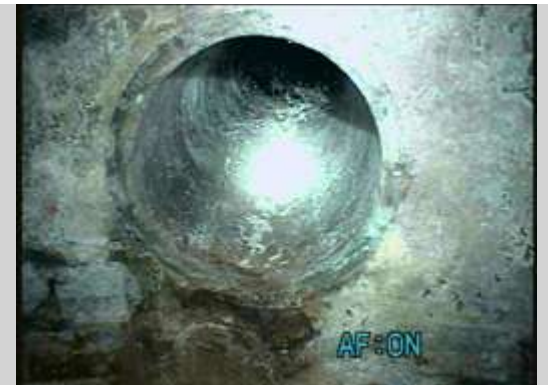
9 O'Clock Inflow

Deposits: ☐ None ☐ Mud ☐ Sludge ☒ Debris ☐ Grease

Silt Depth: 3 (in.) Deposits Extent: Light

Drop Condition: Partly Clogged
